California State Board of Equalization
450 N Street, Sacramento, California

Mold Remediation – 7th Floor
Closure Report Addendum (Revised)
Project No. 2372.02-572

Closure Report Date: August 10, 2010
Addendum Date: October 31, 2012
Addendum Revision Date: January 9, 2013

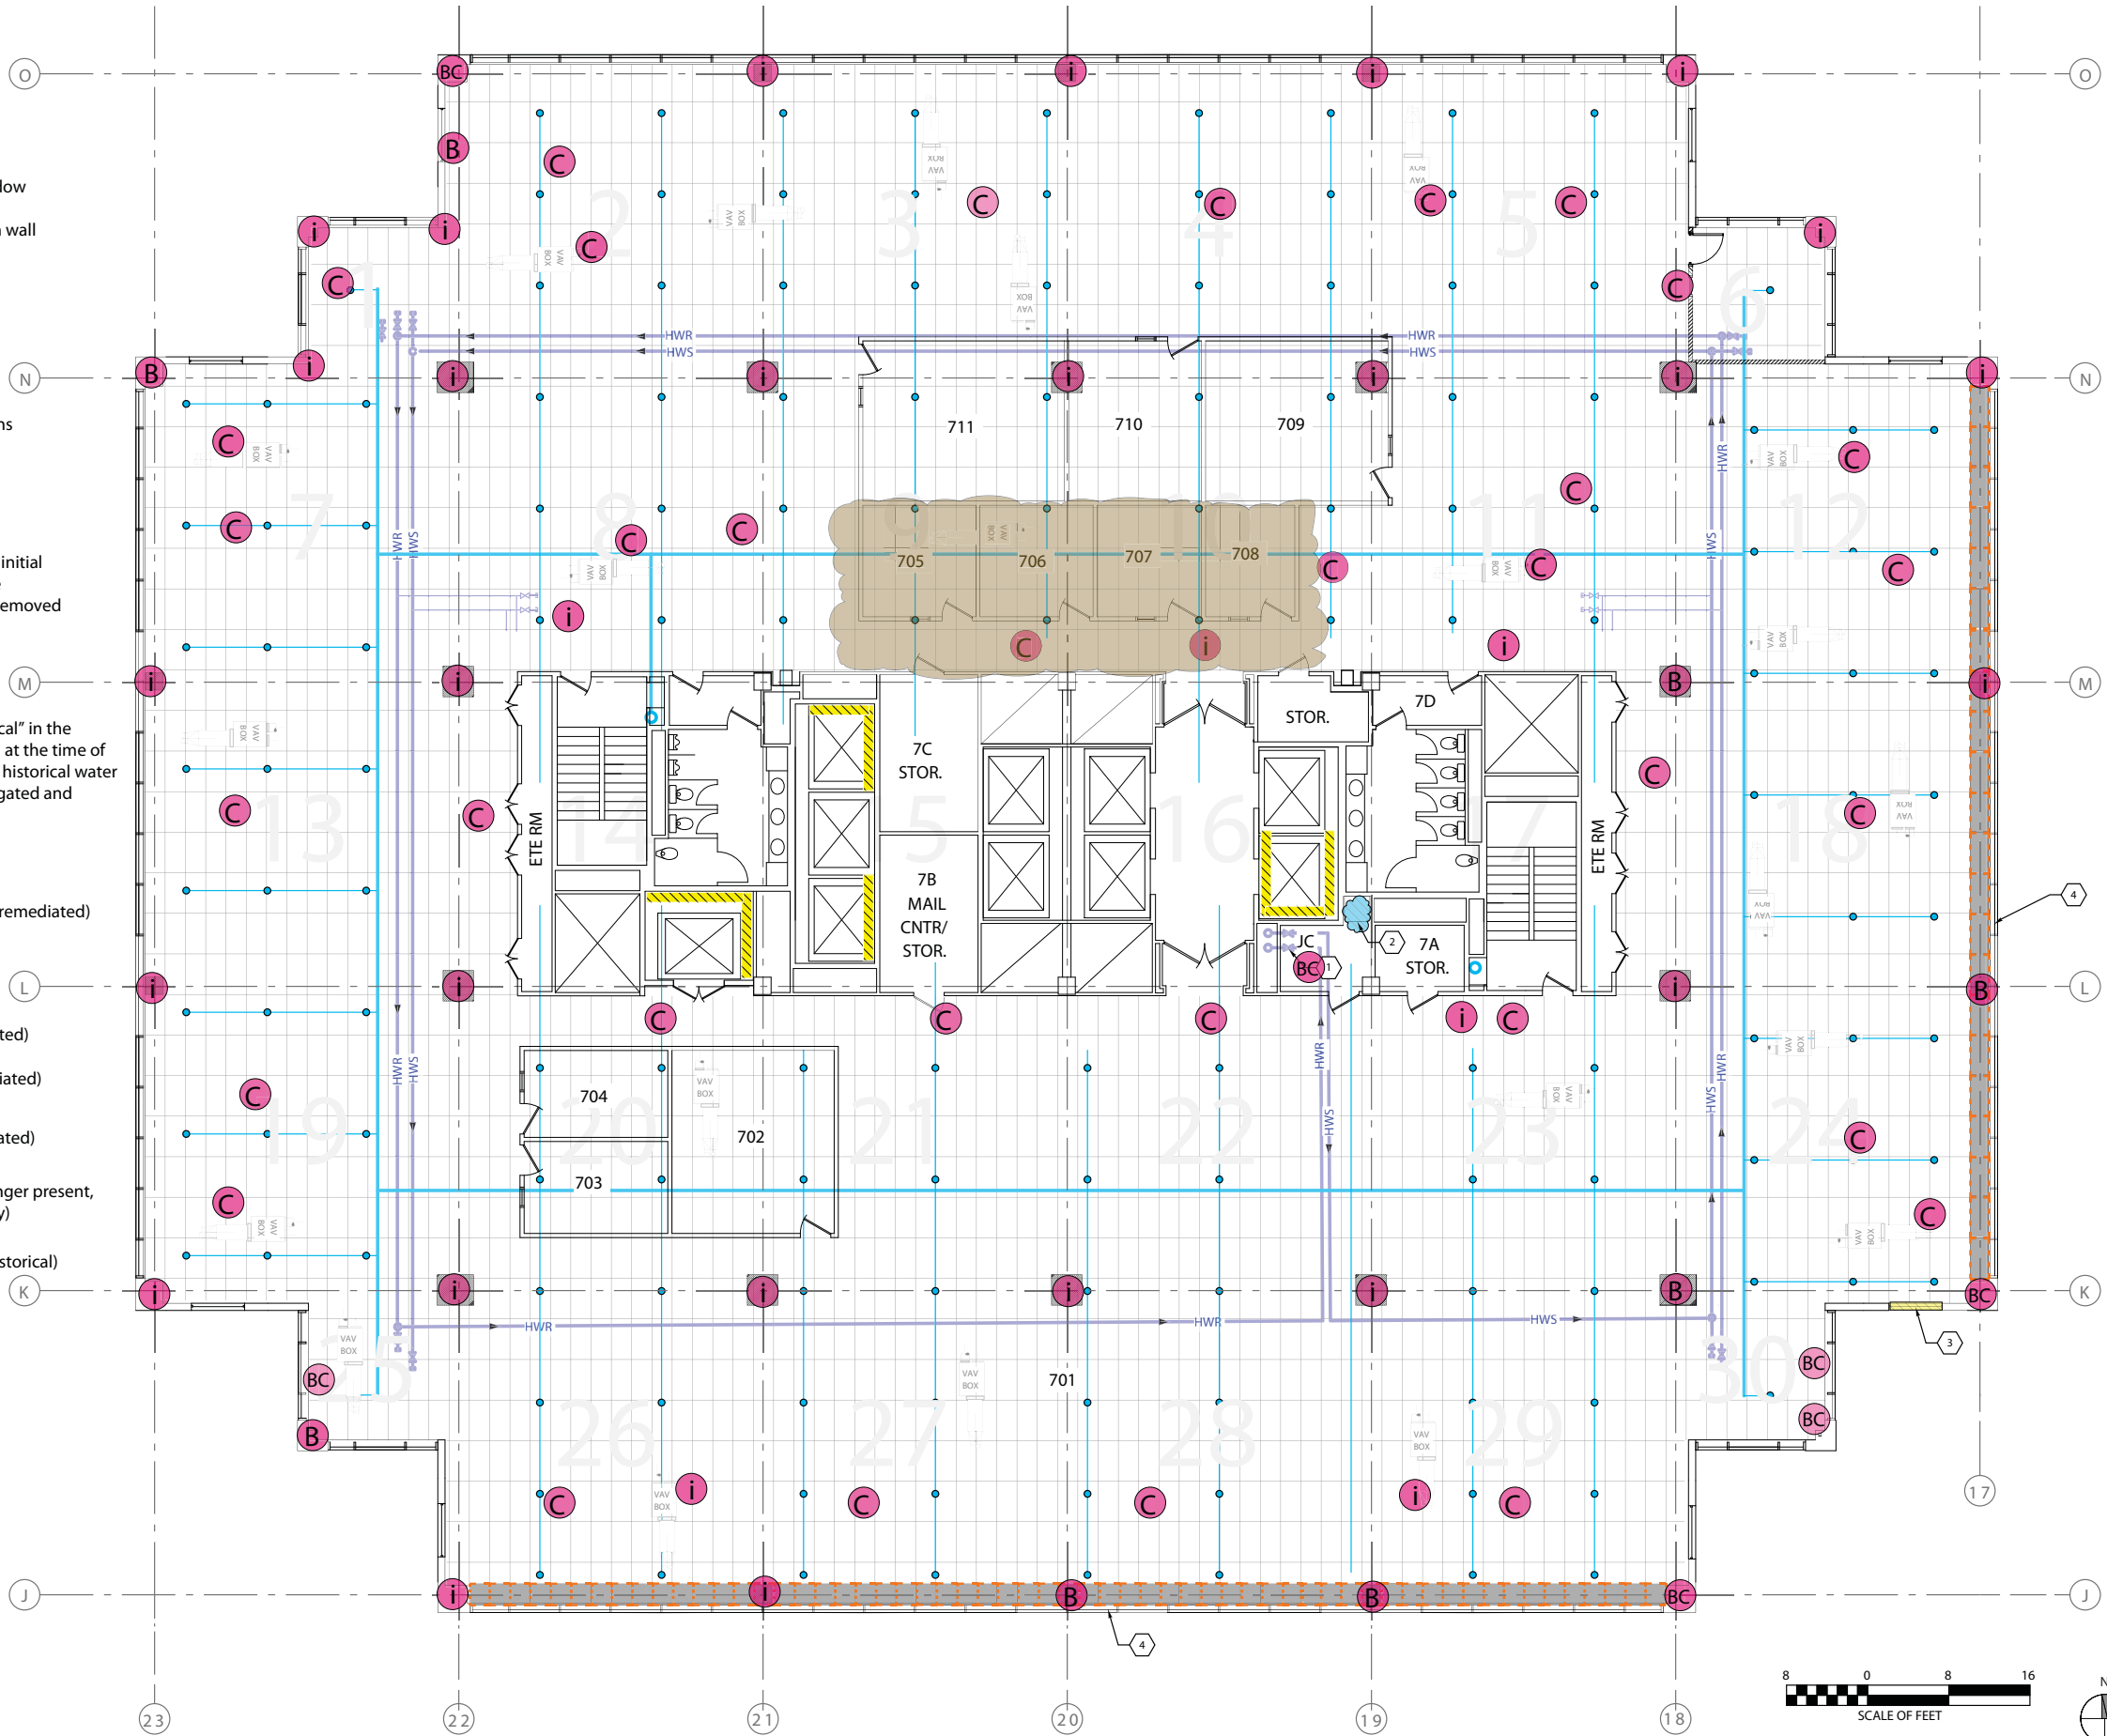
Figure 2

- 1 Rusty valve, water stain
- 2 Standing water on floor
- 3 Water stain on punch-out window
- 4 Water intrusion prior to curtain wall repair in 2005

Containment and Sample Locations (Oct 2012)
Board of Equalization Building, Mold Remediation
450 N Street, Sacramento, California
